S1042-J1-SFR-1

# REPORT

on selected trees at

The Green, Leintwardine SY7 0JZ

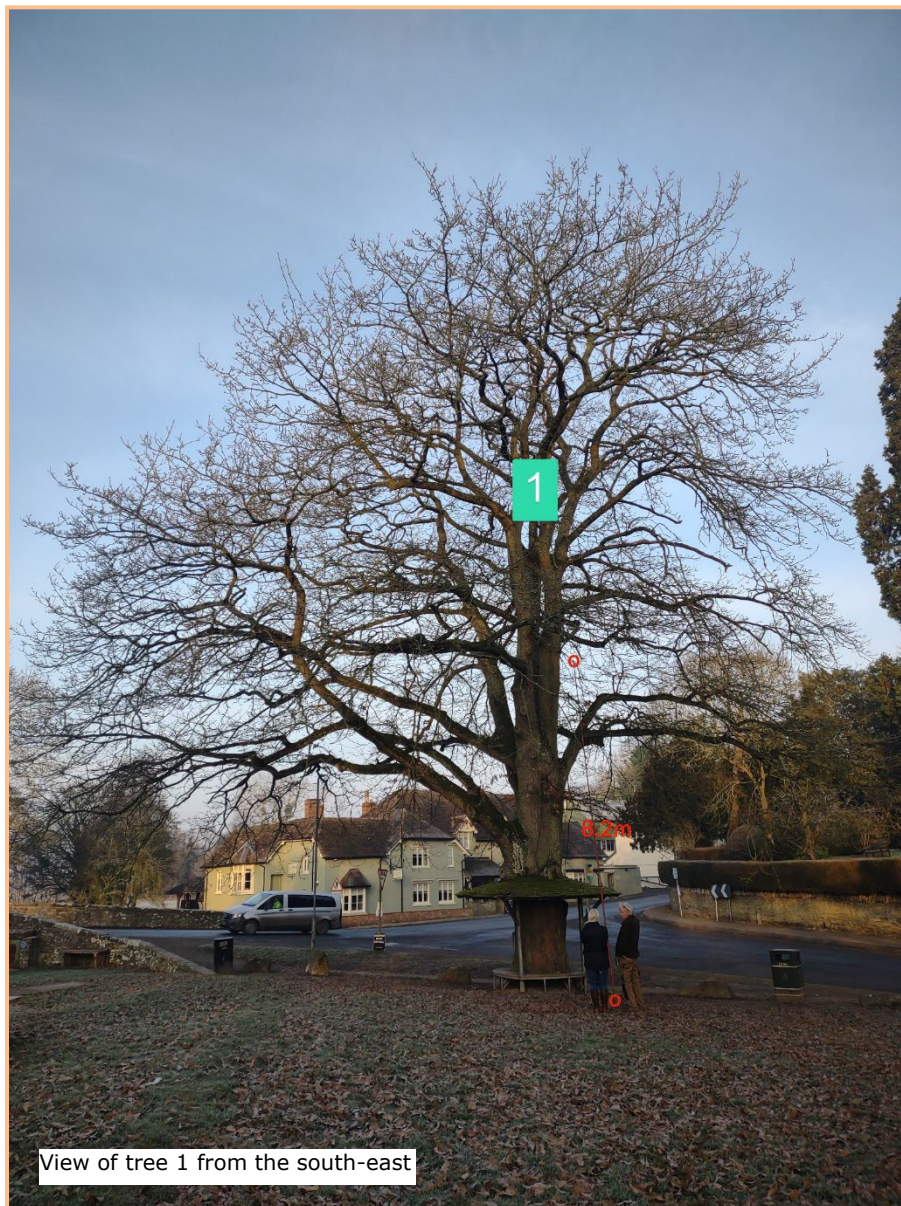
View of tree 1 from the south-east

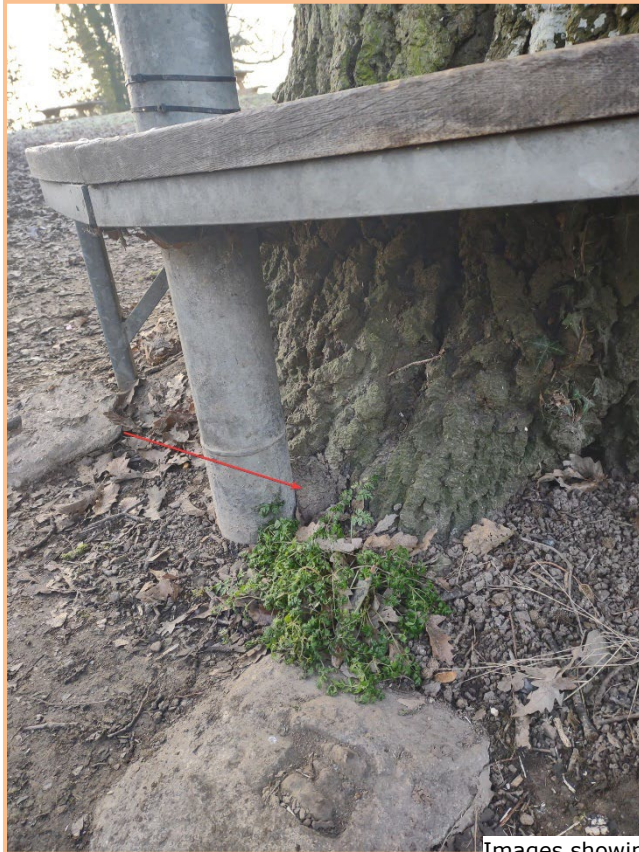
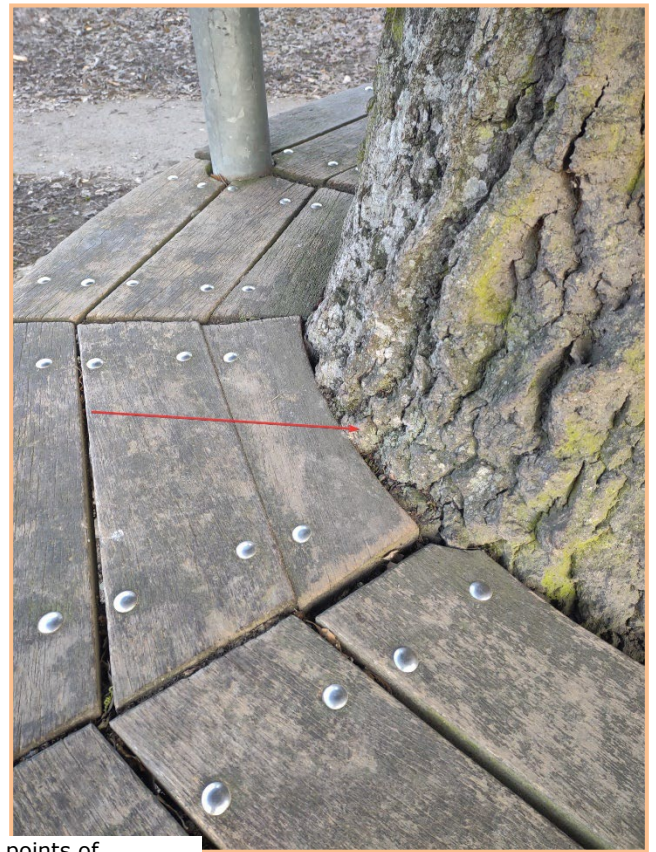
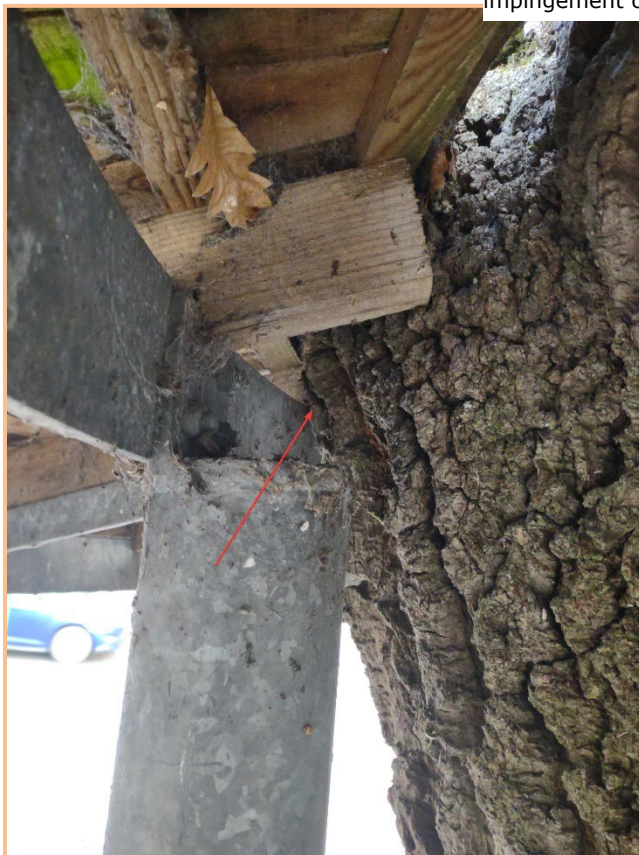
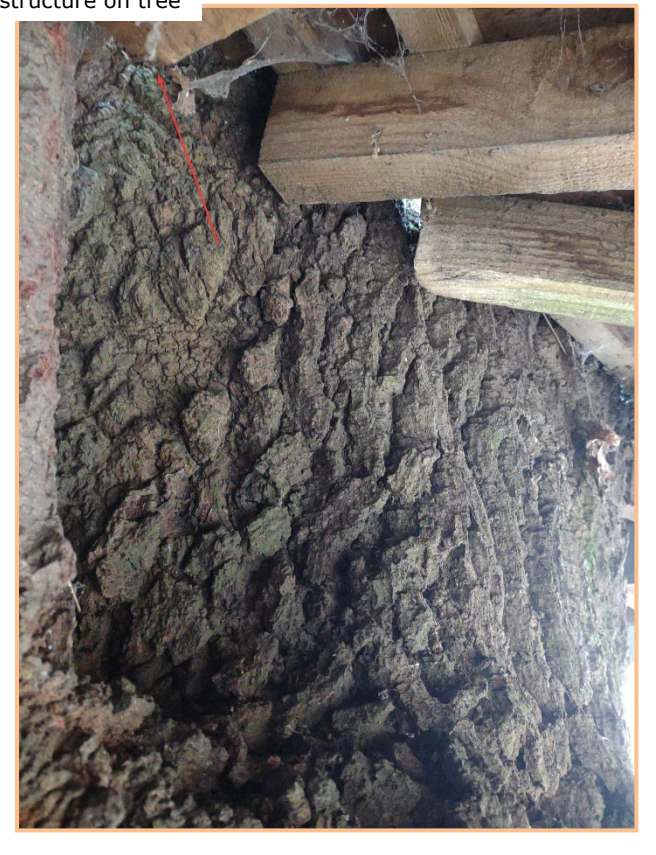
Images showing points of impingement of structure on tree

I am somewhat concerned that some of the ground-bearing supports may have damaged large buttress roots of tree 1. It is perfectly possible these have been installed with some care to avoid such parts of the tree (see photographs above). Steel parts of the structure are close to some parts of the tree and my concern is that the tree will expand and thereafter start to incorporate the steelwork within the tissue of the tree, which would not be desirable. I recommend some redesign and modification of the steel structure so that it is well clear of the tree tissue and allows room for expansion. Consideration should be given to the design life of the structure and possibly a re-think as to whether any structure is needed around the tree. It would be possible to design and position a suitable encircling bench structure some way from the tree. The zone 2m and more from the perimeter bark would probably be free of major roots and ground bearing supports could probably be sited easily enough to miss any significant roots, e.g. those larger than 22mm diameter or so.

Some minor tree management is considered necessary (stabilize dead wood). Beyond this strictly arboricultural point, removing parts of the shelter structure that are impinging on the tree is considered necessary. This, practically, may mean removal of the entire shelter.

All tree work should be carried out to BS 3998: 2010 'Tree Work - Recommendations'. Removal of part or all of the shelter should be carried out under arboricultural supervision with a view to ensuring that no damage occurs to the tree.
