S1042-J1-SFR-1

# REPORT

on selected trees at

The Green, Leintwardine SY7 0JZ

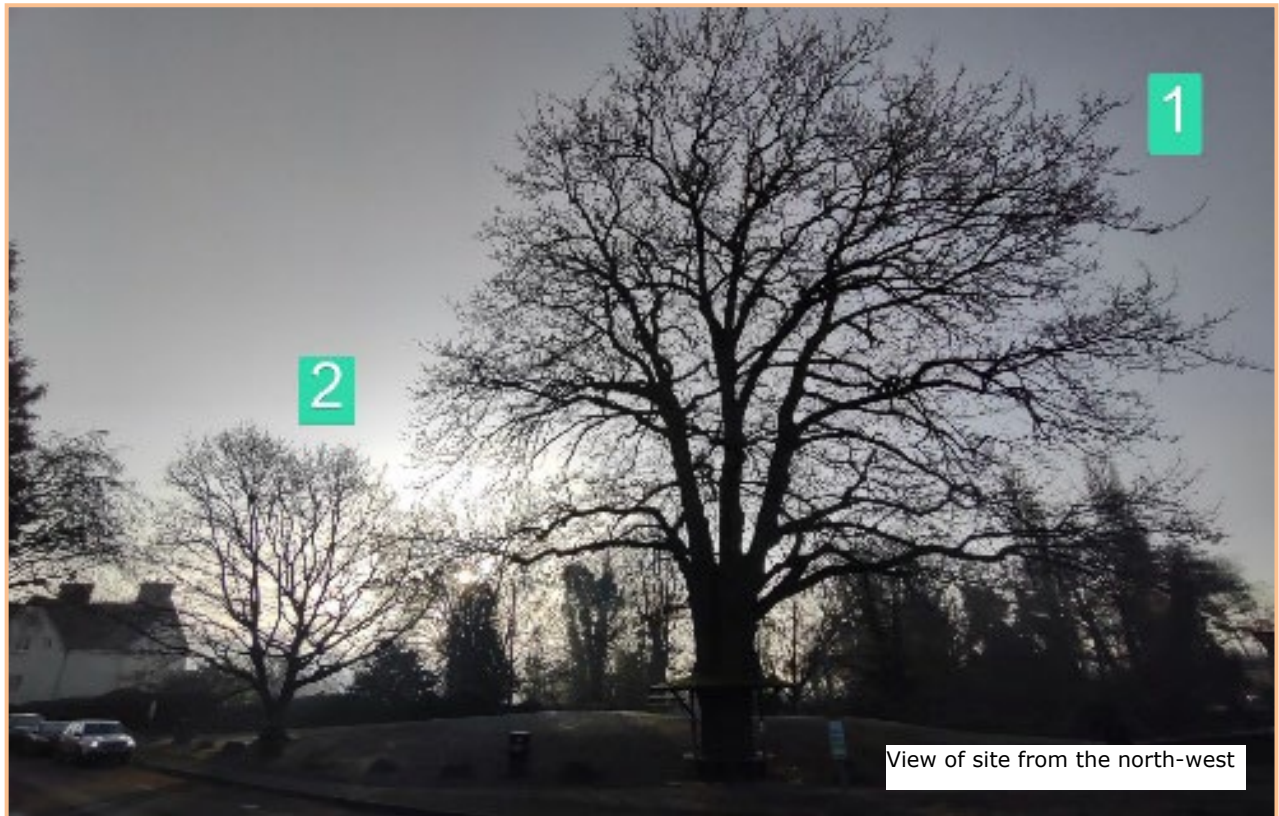
Images showing points of impingement of structure on tree

I am somewhat concerned that some of the ground-bearing supports may have damaged large buttress roots of tree 1. It is perfectly possible these have been installed with some care to avoid such parts of the tree (see photographs above). Steel parts of the structure are close to some parts of the tree and my concern is that the tree will expand and thereafter start to incorporate the steelwork within the tissue of the tree, which would not be desirable. I recommend some redesign and modification of the steel structure so that it is well clear of the tree tissue and allows room for expansion. Consideration should be given to the design life of the structure and possibly a re-think as to whether any structure is needed around the tree. It would be possible to design and position a suitable encircling bench structure some way from the tree. The zone 2m and more from the perimeter bark would probably be free of major roots and ground bearing supports could probably be sited easily enough to miss any significant roots, e.g. those larger than 22mm diameter or so.

Some minor tree management is considered necessary (stabilize dead wood). Beyond this strictly arboricultural point, removing parts of the shelter structure that are impinging on the tree is considered necessary. This, practically, may mean removal of the entire shelter.

All tree work should be carried out to BS 3998: 2010 'Tree Work - Recommendations'. Removal of part or all of the shelter should be carried out under arboricultural supervision with a view to ensuring that no damage occurs to the tree.

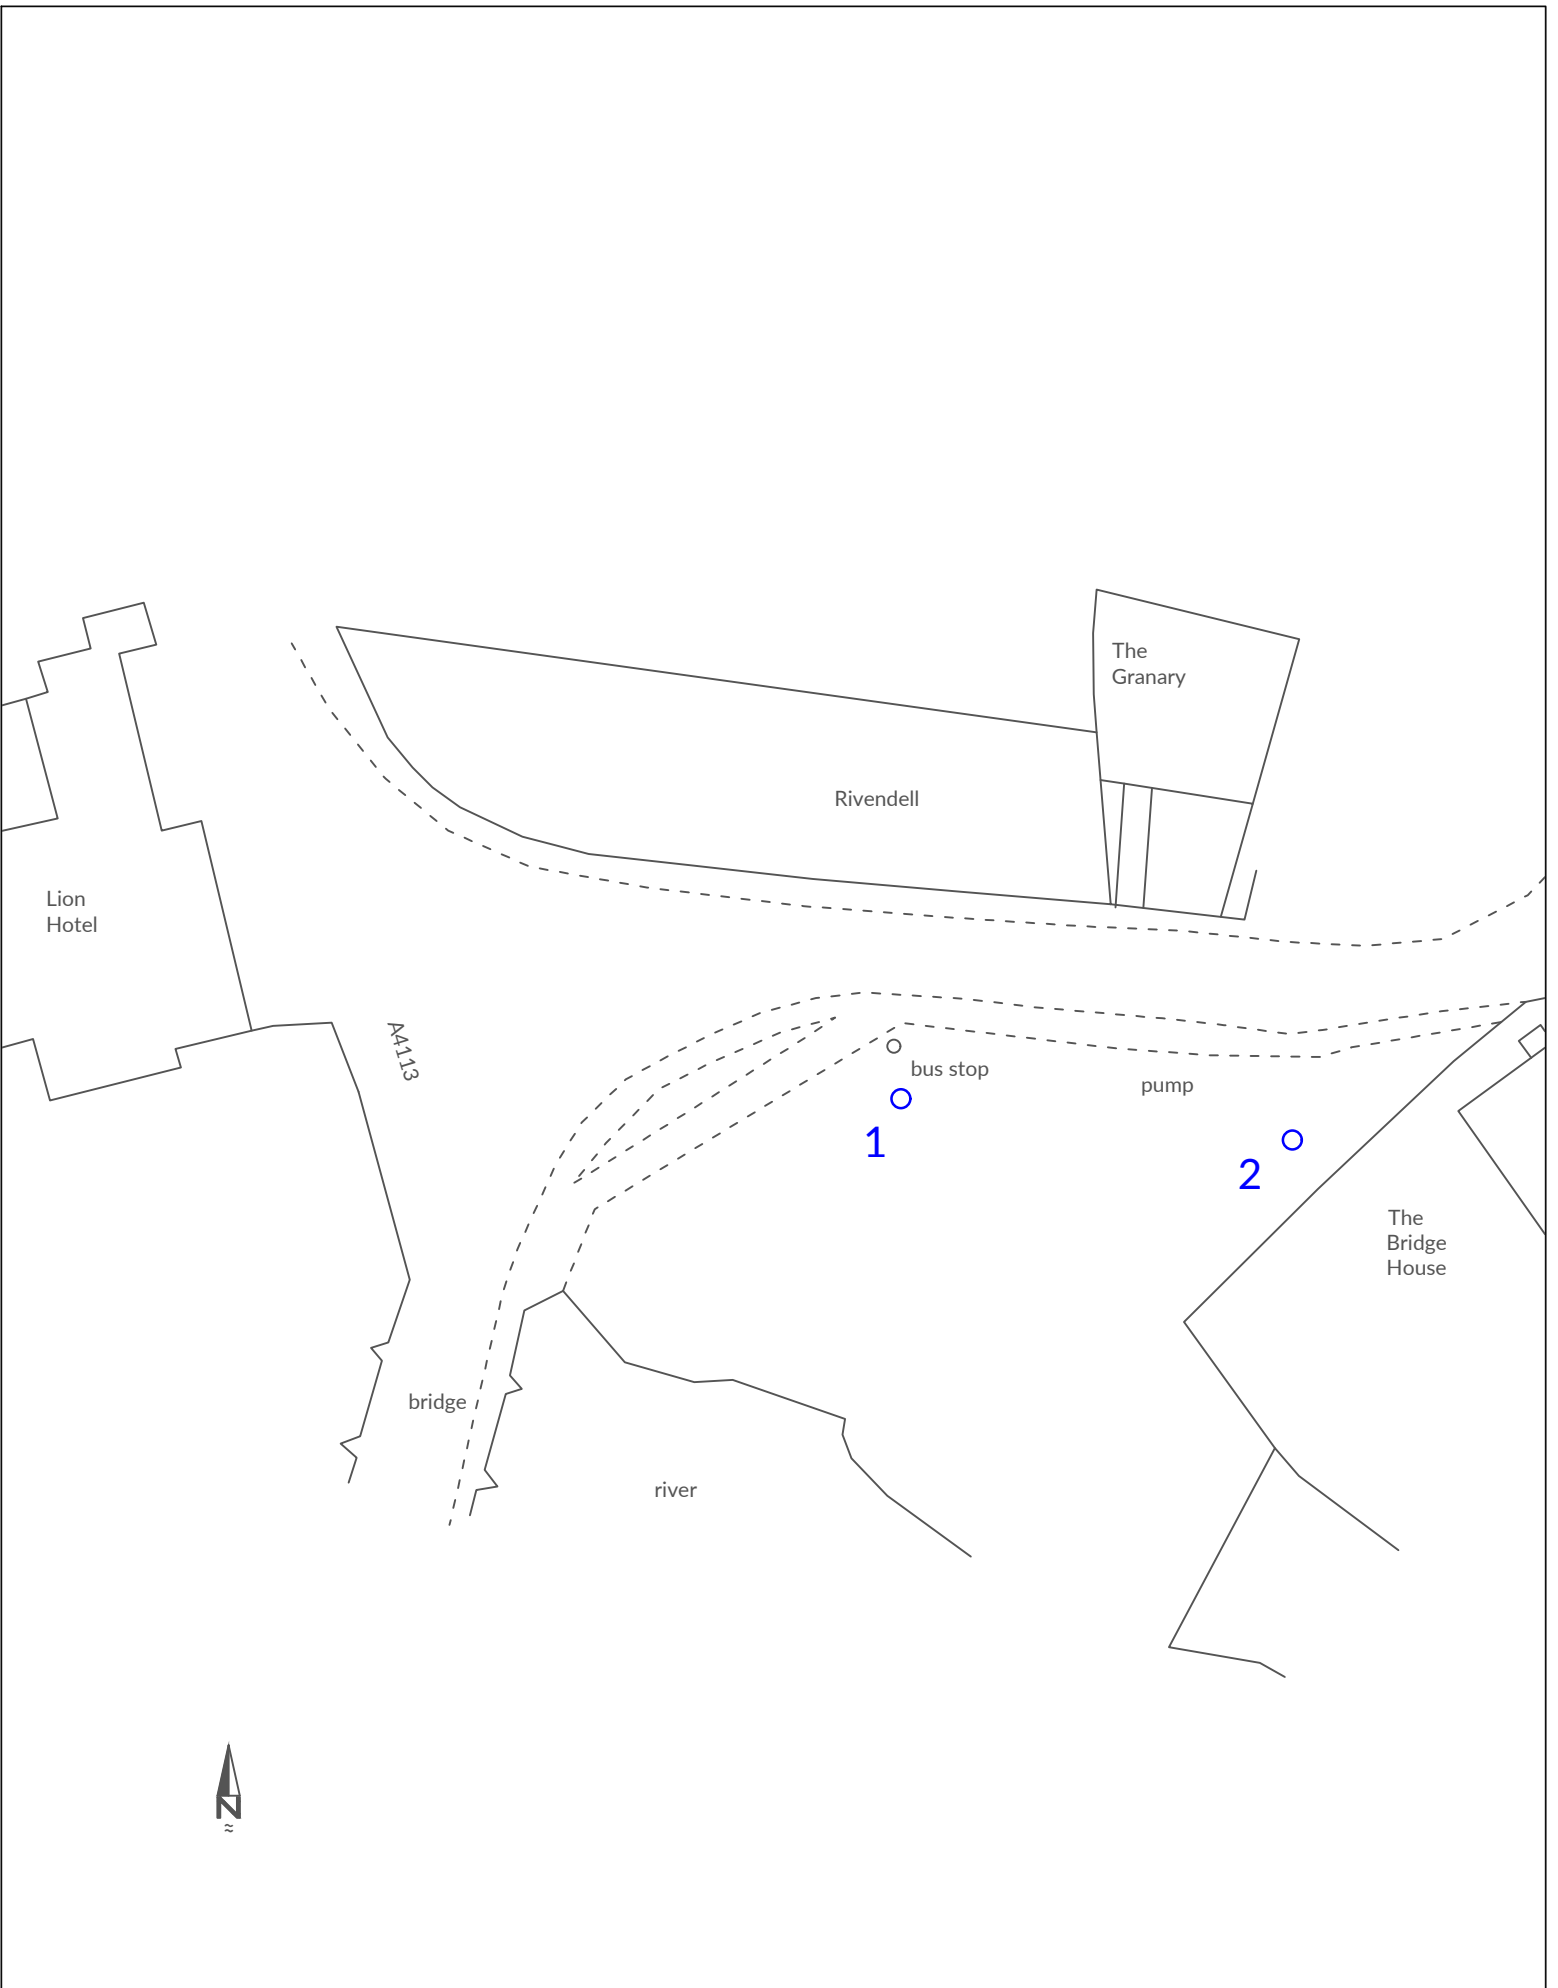
Plan NTS @ A4

Trees in relation to The Green, Leintwardine SY7 0JZ  
S1042-J1-P v1
